TOSHIBA AMERICA INFORMATION SYSTEMS, INC.
Computer Systems Division - Technical Service and Support
9740 Irvine Blvd., Irvine, CA 92718
(714) 583-3000

ISSUE ALERT LETTER #14

Attached is Issue Alert Letter #14 detailing a screen problem and its fix on T21XXCS systems.

Issue Alert Letter #14

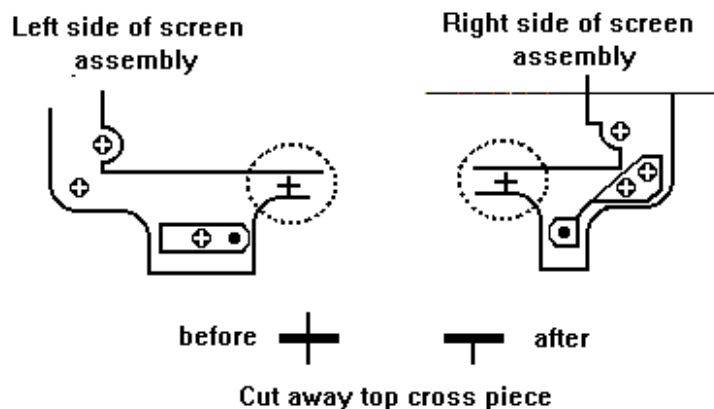
During reassembly, the screen on a T21XXCS system is often positioned too low and allowed to contact the cross-shaped posts molded into the bottom edge of the top cover. If a sufficient gap is not maintained between the edge of the screen and the post, light shock or the closing action can leave small indentations on the metal frame of the screen. These indentations may cause damage to the drivers mounted along the bottom edge beneath the frame. This can result in vertical lines being displayed or dark screen failures.

To eliminate the possibility of damage, the top cross piece of both the left and right side posts should be cut away as shown in the illustration.

This piece can be shaved down using small diagonal cutters or a knife. The piece removed may have a conductive coating, so care should be taken to prevent pieces of the cut plastic from dropping down into the system. This cut should be applied anytime a T21XXCS system is brought in for service.
