The MITO™ 5/MITO™ 6

PARTS CATALOG

MODEL #H519000
MODEL #H520000
MODEL #H522000
MODEL #H523000
ISSUE DATE: 10/96
CATALOG #K243000

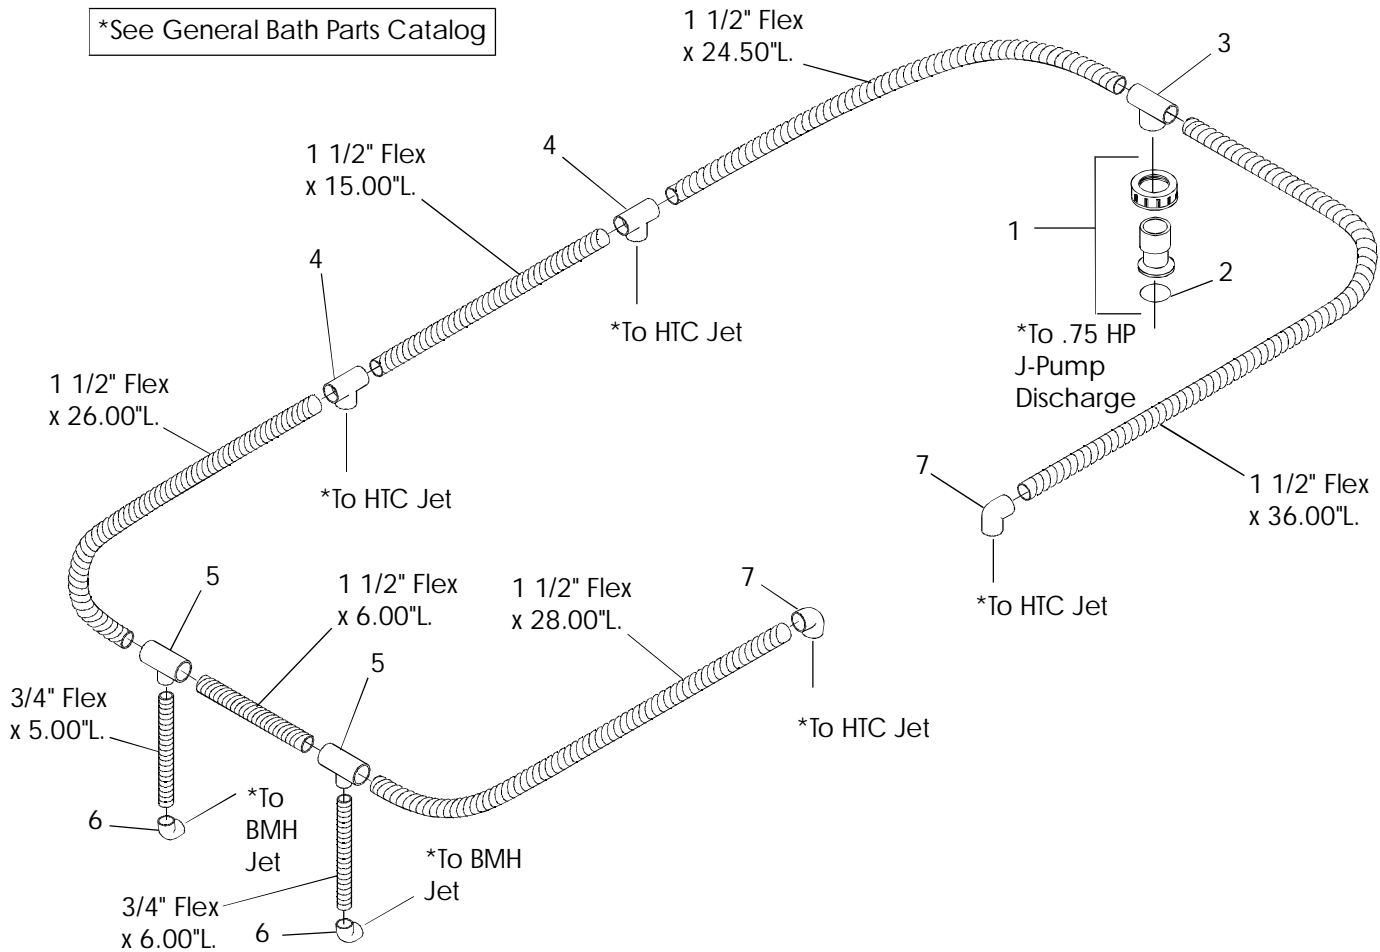
DISCHARGE PLUMBING - MITO 5

NOTE: RH discharge plumbing configuration shown.

ITEM	P/N	DESCRIPTION	QTY
1	9250000	Repair Kit, Union Adapter	1
2	9231000	O-Ring, Union	1
3	2949000	Tee, Rdcng, 1 1/2 x 1 1/2 x 2	1
4	0167000	Tee, 1 1/2, S x S x S	2
5	D189000	Tee, Rdcng, 1 1/2 x 1 1/2 x 3/4, S x S x S	2
6	D221000	Ell, 3/4, 90, S x S	2
7	0239000	Ell, 90, 1 1/2, S x S	2

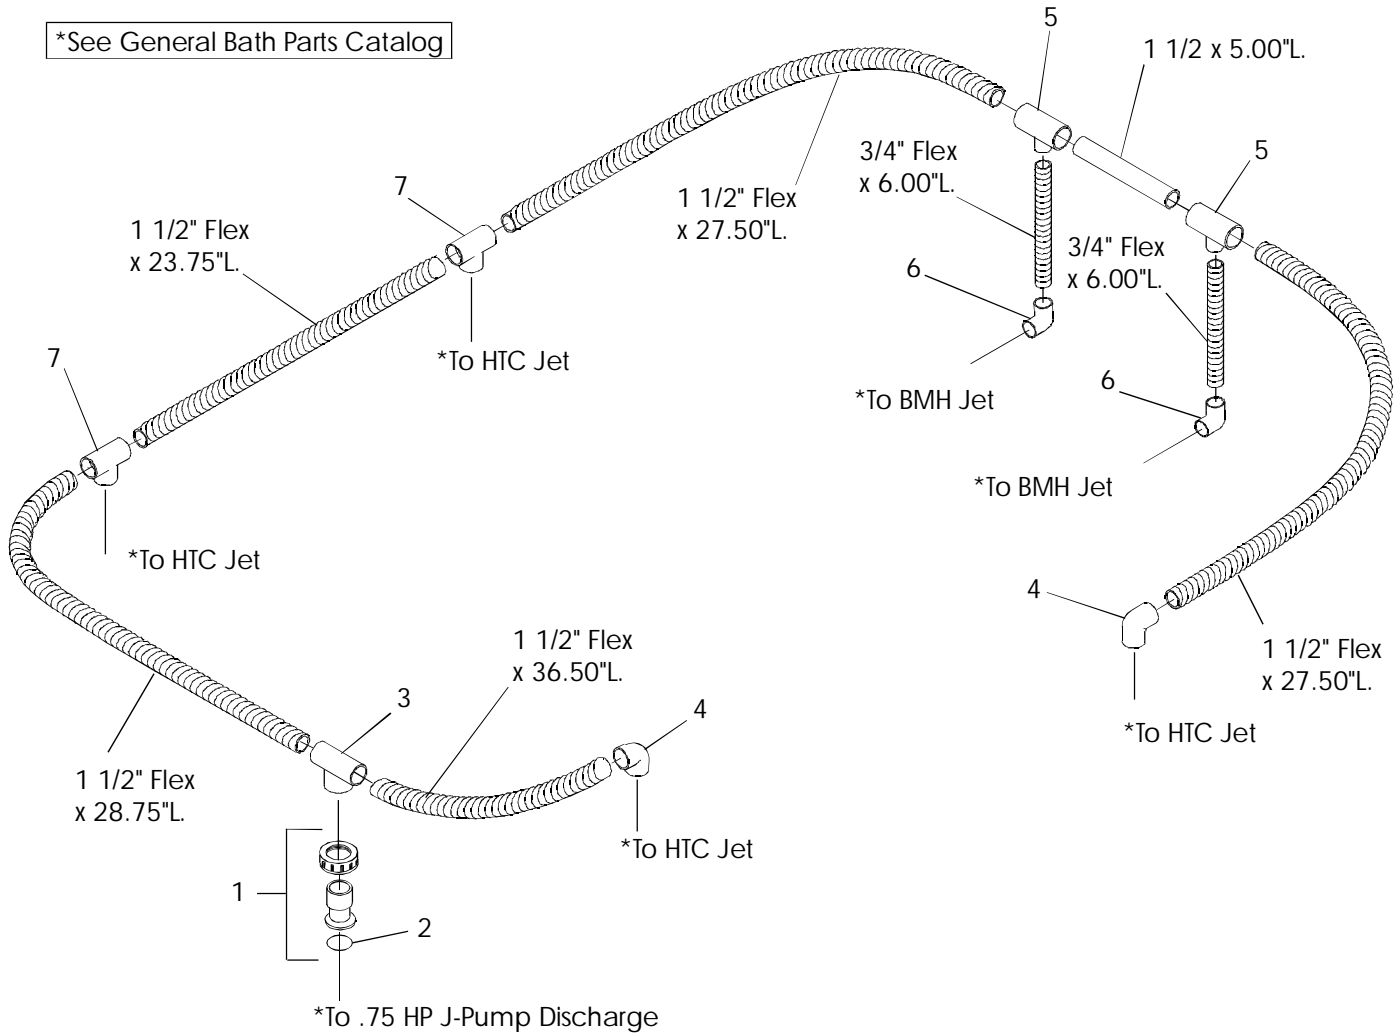
DISCHARGE PLUMBING - MITO 6

NOTE: LH discharge plumbing configuration shown.

ITEM	P/N	DESCRIPTION	QTY
1	9250000	Repair Kit, Union Adapter	1
2	9231000	O-Ring, Union	1
3	2949000	Tee, Rdcng, 1 1/2" x 1 1/2" x 2"	1
4	0239000	Ell, 90, 1 1/2" S x S	2
5	D189000	Tee, Rdcng, 1 1/2" x 1 1/2" x 3/4", S x S x S	2
6	D221000	Ell, 3/4, 90, S x S	2
	0167000	Tee, 1 1/2", S x S x S

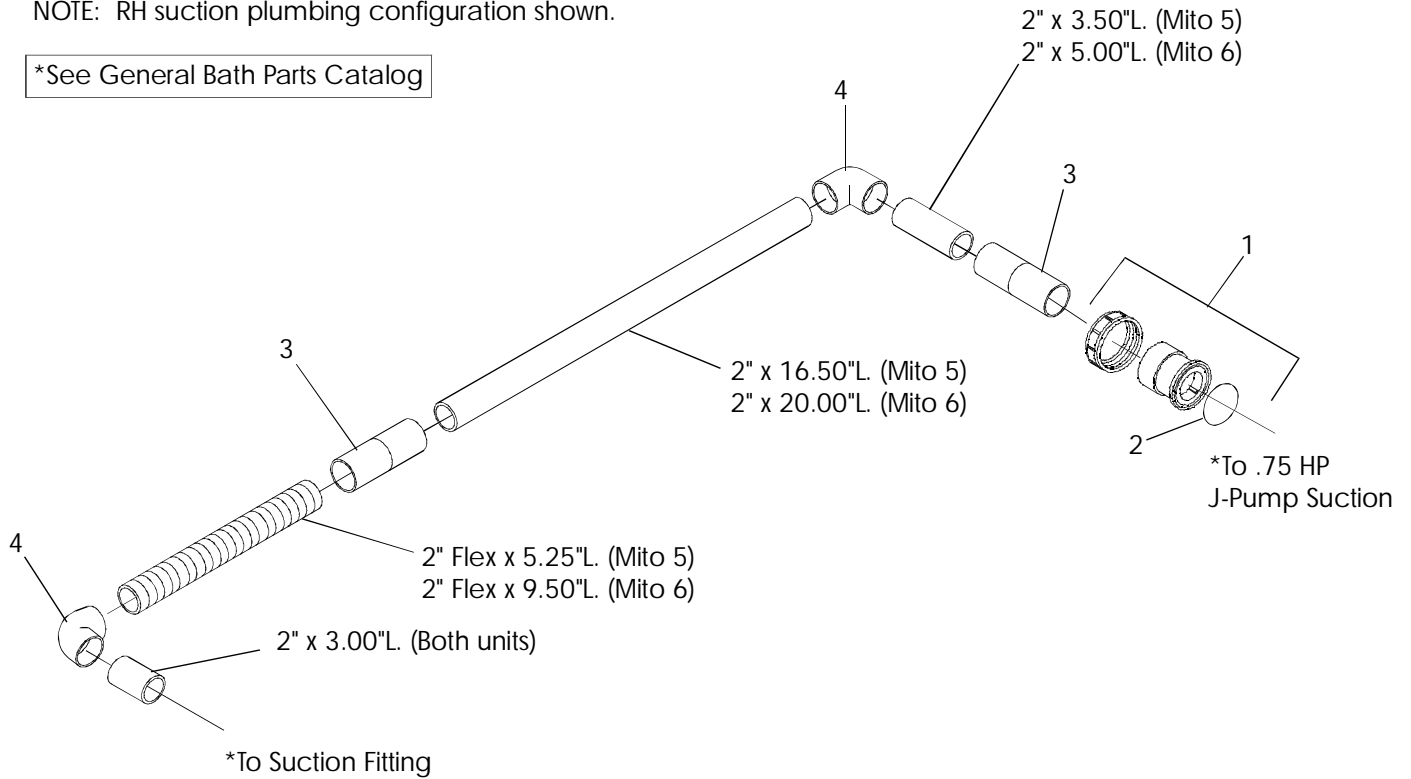
SUCTION PLUMBING - MITO 5/MITO 6

NOTE: RH suction plumbing configuration shown.

ITEM	P/N	DESCRIPTION	QTY
1	9250000	Repair Kit, Union Adapter	1
2	9231000	O-Ring, Union	1
3	0851000	Coupling, 2" S x S	2
4	0426000	El, 90, 2" S x S	2

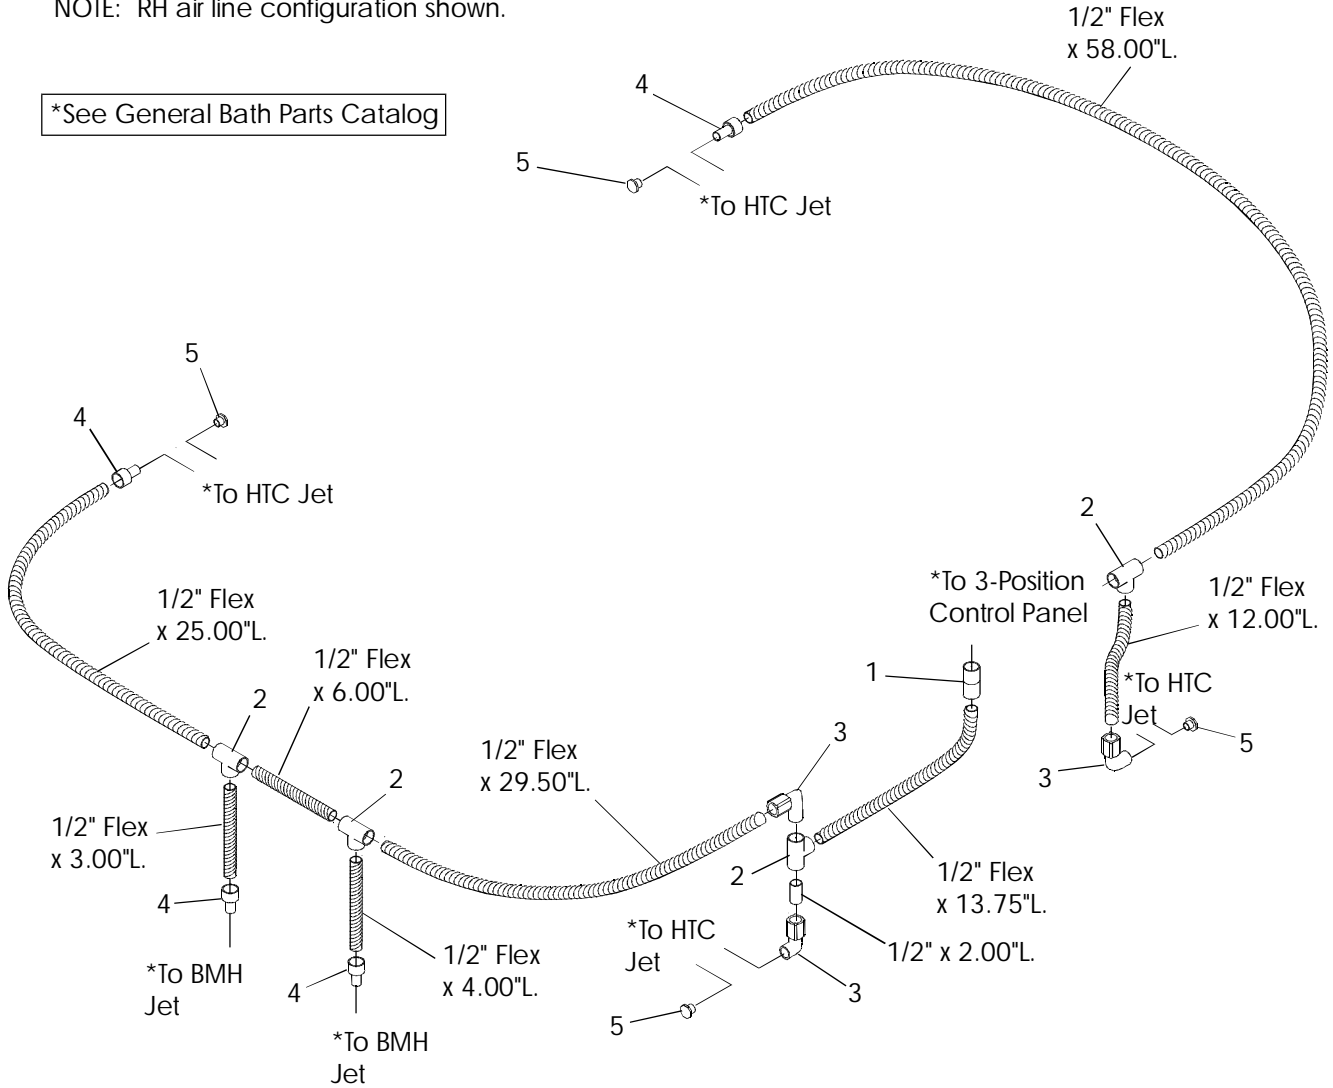
AIR LINE PIPING - MITO 5

NOTE: RH air line configuration shown.

ITEM	P/N	DESCRIPTION	QTY
1	0647000	Coupling, 1/2" S x S	1
2	0455000	Tee, 1/2" S x S x S	4
3	7164000	El, Street, 1/2" 90	3
4	C279000	Adapter, 1/2" S x SPGT	4
5	B777000	Plug, 1/2" SPIG	4

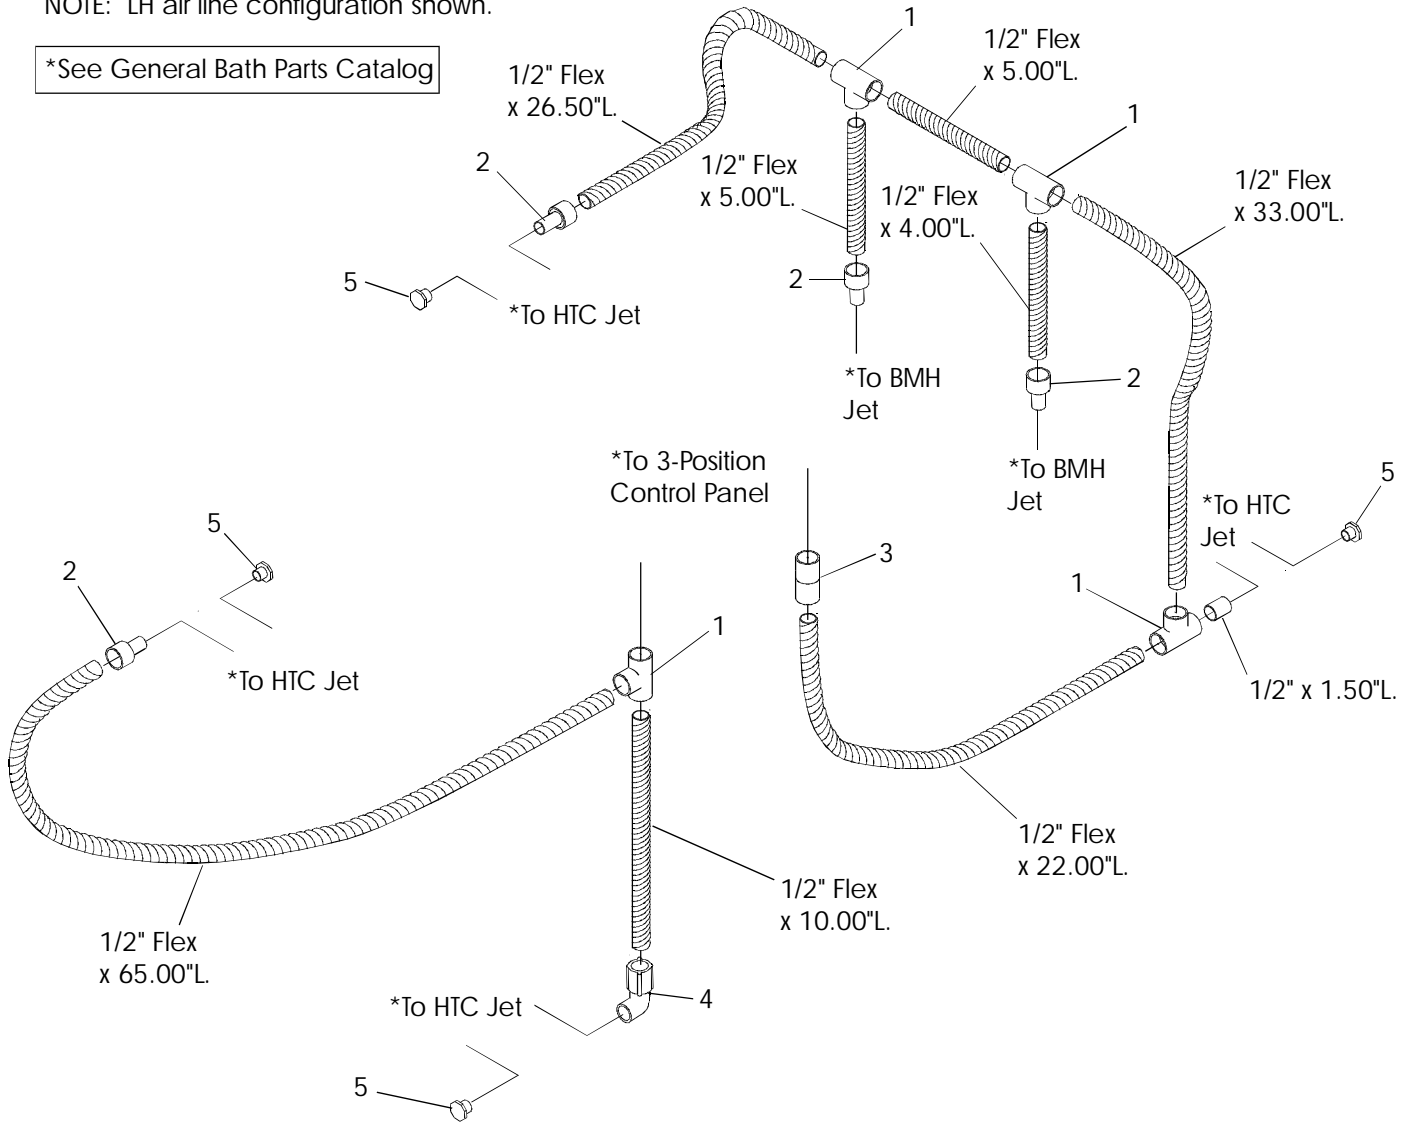
AIR LINE PIPING - MITO 6

NOTE: LH air line configuration shown.

ITEM	P/N	DESCRIPTION	QTY
1	0455000	Tee, 1/2" S x S x S	4
2	C279000	Adapter, 1/2" S x S x S	4
3	0647000	Coupling, 1/2" S x S	1
4	7164000	El, Street, 1/2" 90	1
5		Plug, 1/2" SPIG	1
